**Re: George Collins and
Alrika Collins,
Plaintiffs,**

**State Farm Fire and
Casualty Company,
Defendant.**

**United States District Court for
the Eastern District of Oklahoma
Case #: 22-CV-00318-RAW-JAR**

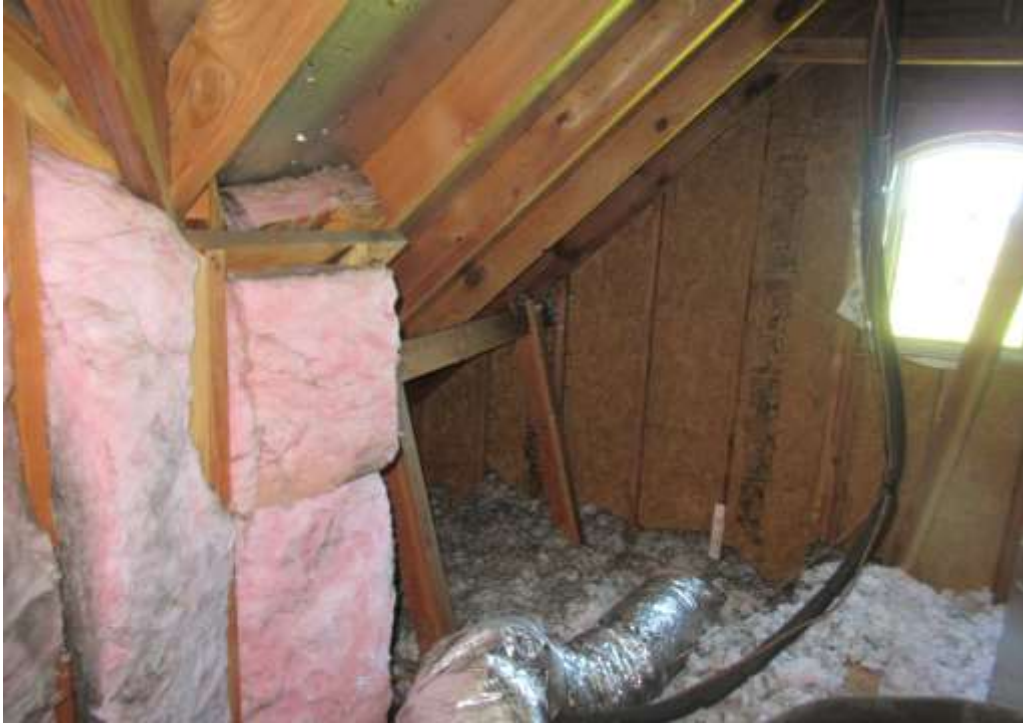
The walk-in attic to the east of the theater room. This area suffered no fire damage.
Minimal smoke residue was evident.

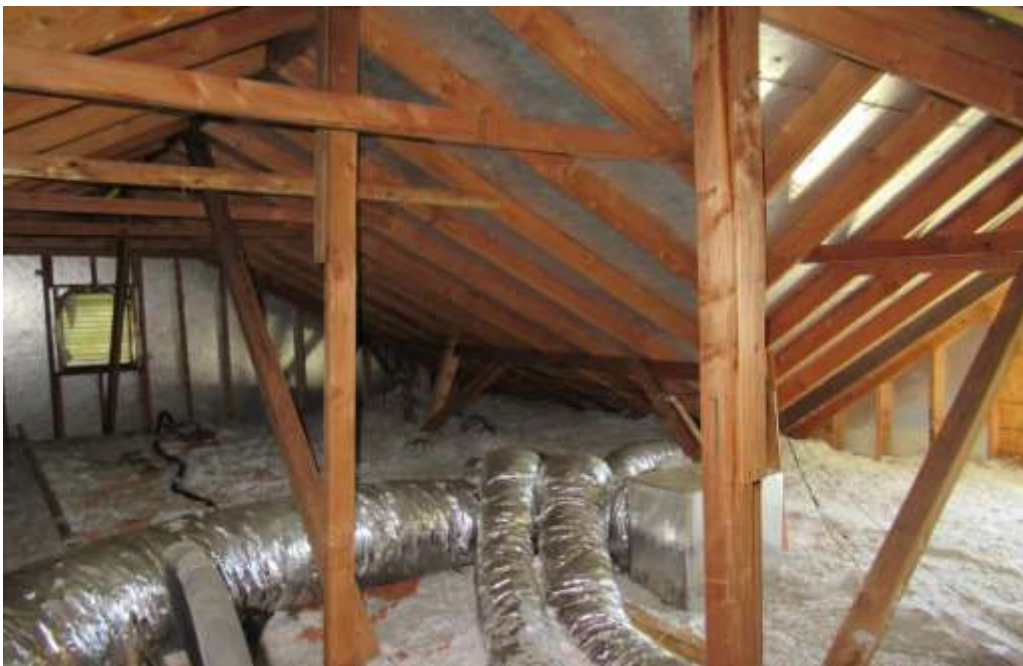
Attic 2. Except for a small area at the gable wall, the fire did not reach this space.

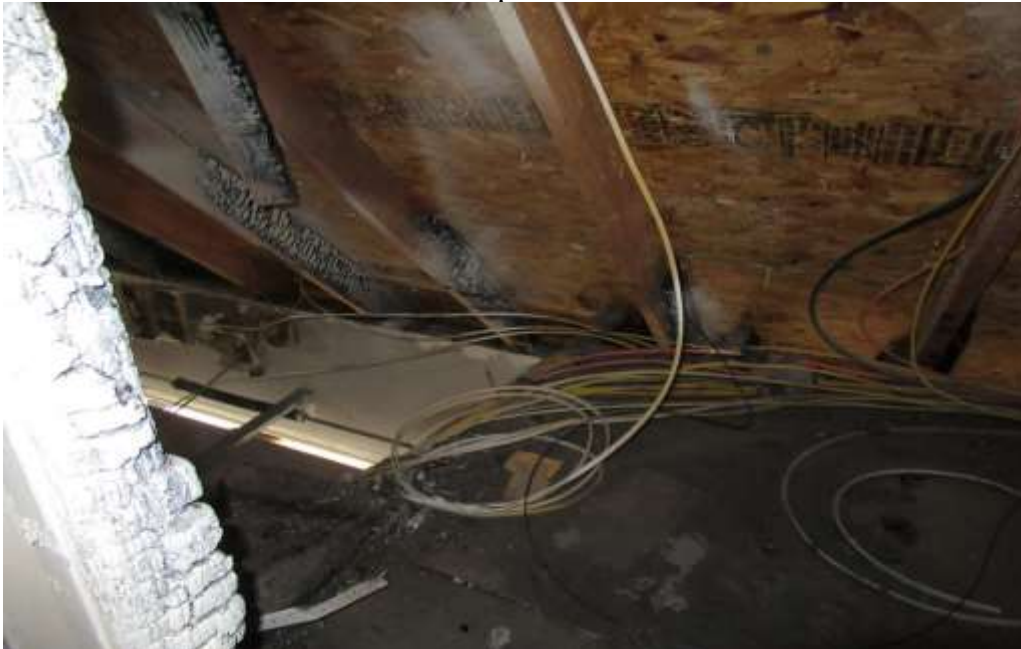
The roofs decking has been replaced but partially charred rafters remain.

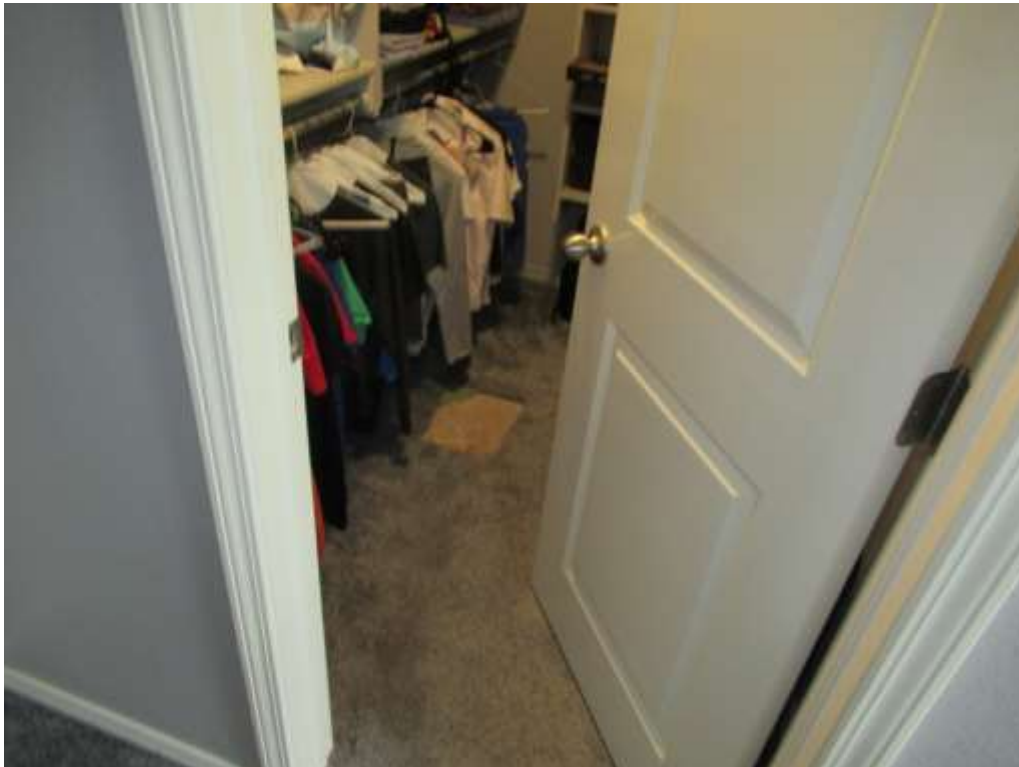
The carpeting in the closet of Bedroom 1 with the same home hole from the carpet sample extraction as seen on page 15 of this report.

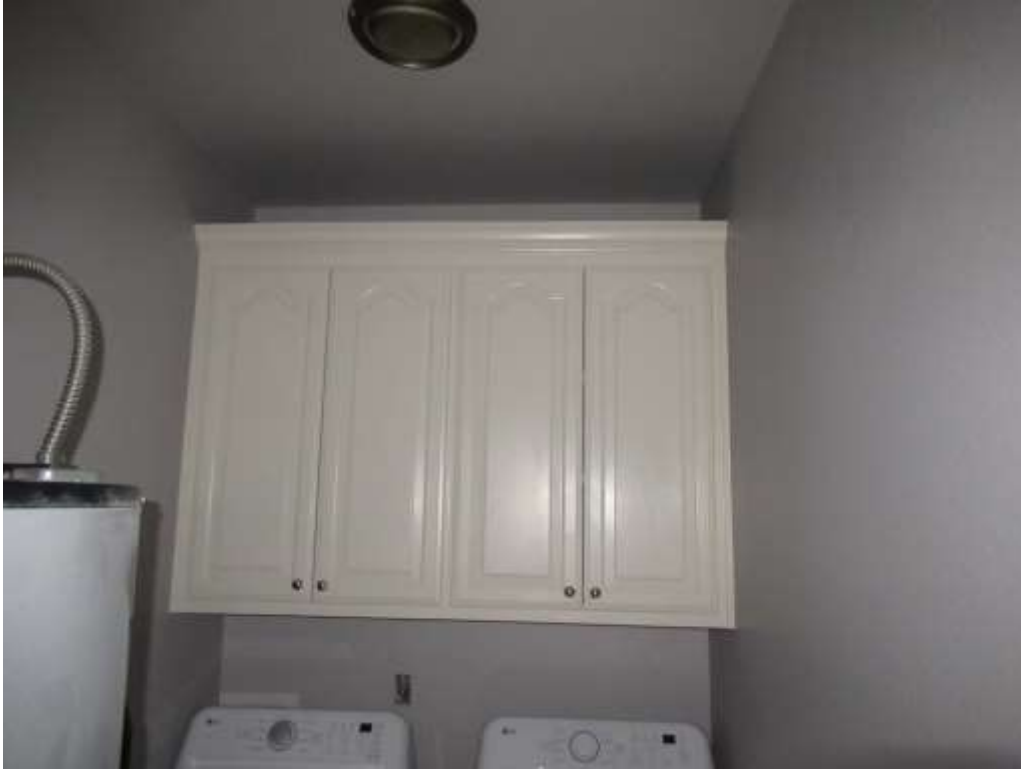
The original hot water heater located in the laundry room. The installation and inspection stickers are dated January 2016.

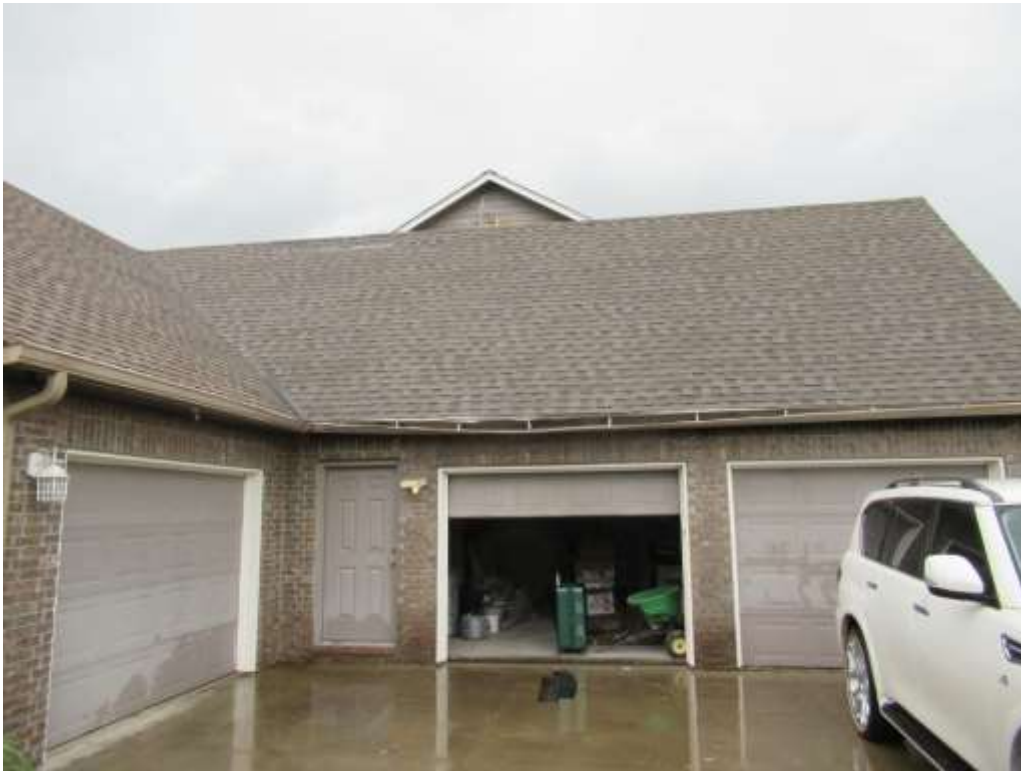
The section of the roof which had been re-roofed.

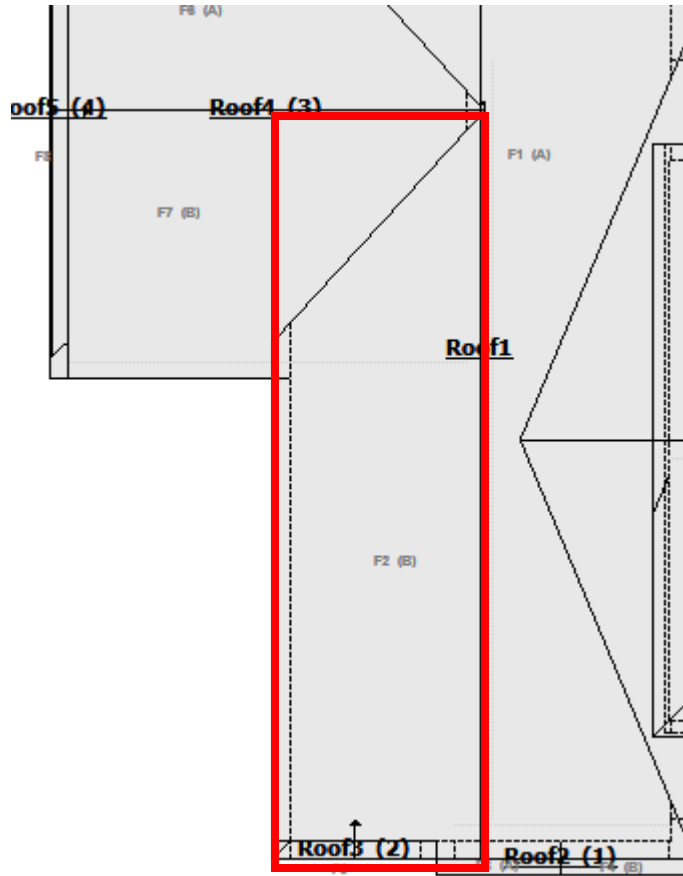
The interior of the box is the approximate area of the roof which was re-shingled.
